### Nuclear waste screening

An x-ray screening solution for Amersham PLC

## Amersham: a case study in x-ray screening of nuclear waste

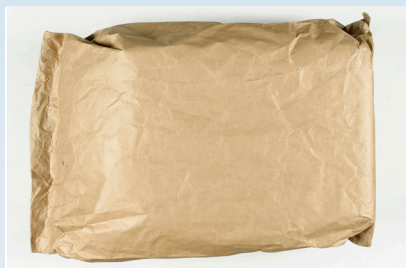
Waste for screening

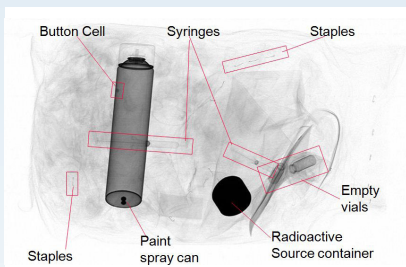
X-ray of paint spray can, batteries, radioactive source container, syringes and staples in waste

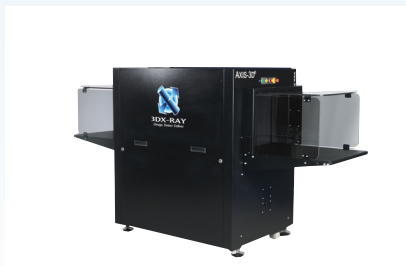
3D x-ray solution for screening bags of waste

The AXIS-3D® offers the perfect solution. It provides both a real time 3D stereoscopic x-ray image of the contents of the sack and, with our enhanced systems software, highlights organic fluids such as filled syringes or glass vials.

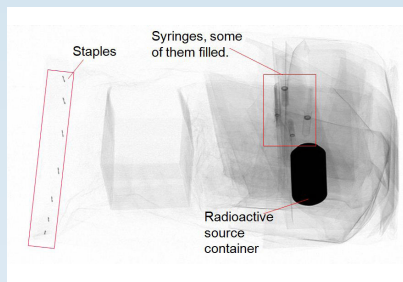
X-ray of radioactive source container, syringes and staples in waste

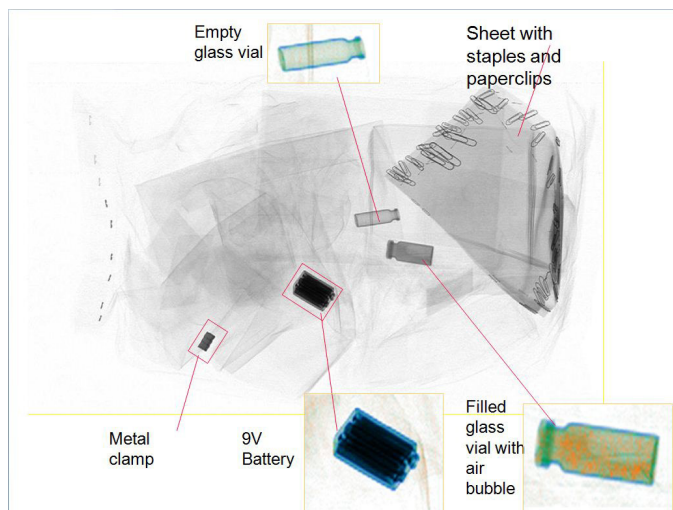
The image above is a prepared waste sack containing examples of non-compliant items. It clearly shows how the presence of batteries, syringes and even needles can be readily identified. A modified version of our dual energy x-ray analysis technique for materials discrimination also enables the system to highlight organic fluids within, in this case, a glass vial.
